Case Study: Performance of a House Built on a Treated Wood Foundation System in a Cold Climate

Charles G. Carll

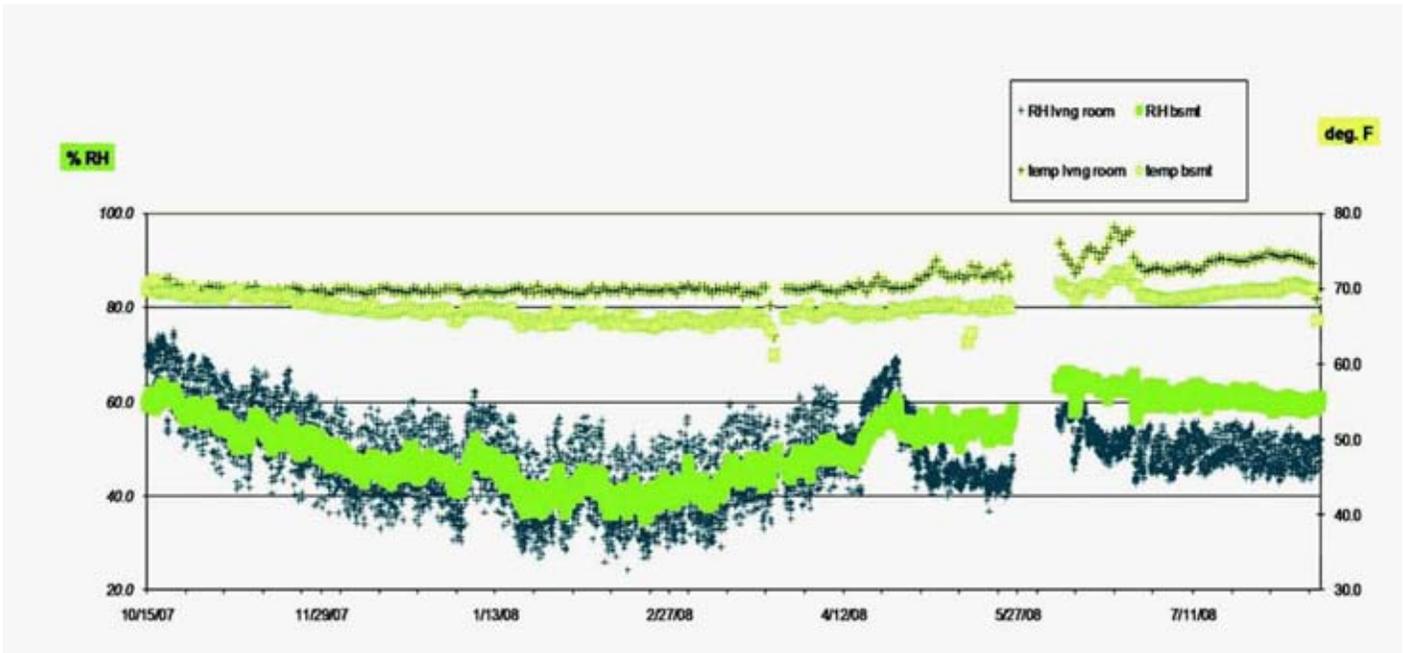
Figure 1 Living room and basement hourly temperature and RH values from mid-October 2007 to mid-August 2008.

Conditions on the first story (living or “great” room) and in the basement over much of the 2007–2008 heating season and part of the 2008 cooling season are shown in Figure 1. The figure includes a short period in April 2008 when there was a malfunction of the heating system, and a period in June 2008 when there was a malfunction of the cooling system. Temperature and humidity plots for other years showed generally similar trends. Figure 1 indicates that basement and living room temperatures converged in mid autumn. During winter, spring, and summer, basement temperatures were consistently cooler than living room temperatures, although the temperature differences were never great. Unless there was a malfunction of the mechanical system, daily average temperature in the basement, without exception, remained within 6°F of 70°F. The basement may thus be characterized as having been a very well-tempered space, despite the fact that it is not provided with supply or return registers. The combination of conductive and radiant heat transfer from uninsulated ductwork, duct leakage, and air exchange between the house and the basement was sufficient to keep the basement at temperatures reasonably close to indoor set-point temperature conditions.

Figure 1 indicates that, during the heating season (when humidifiers were operated on first and second stories), hourly humidity conditions in the basement were relatively stable compared with those in the living room. This reflects the manner in which the humidifiers were operated: manually charged each day with an aggregate total of 10 L, and run continuously, with the charge completely evaporated before

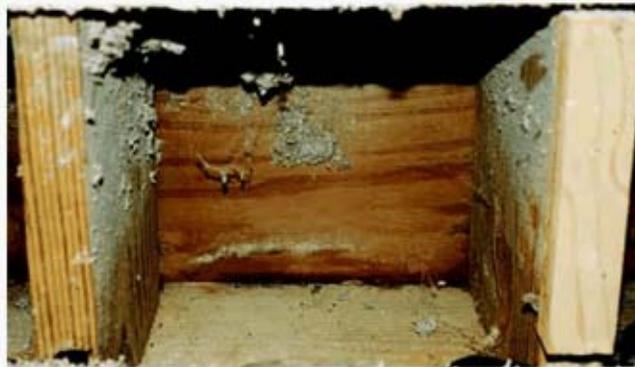
Figure 2 Section of foundation wall bottom plate, showing the interface between bottom plate and plywood sheathing. Foundation wall studs are to left and right of picture. Plywood and bottom plate are visibly wet at their interface. Gray material containing red and white flecks (adhered to plywood and to left stud) is cellulose insulation. White rime above wet area is composed primarily of mycelia of a mold fungus. Bottom plate and plywood, although at moisture contents near fiber saturation, show no obvious mold growth.

During intrusive investigation, we only observed limited patches of mold growth in foundation walls. These were located at the base of the wall on the uphill side of the building (see Figure 2) and on the back surface of interior gypsum board near the top of the foundation wall (on the opposite side of the building). These patches of mold growth quite likely occurred during construction. As indicated in Carll et al. (2007), wall bases underwent substantial and obvious wetting before roof gutters were installed and the site was graded. In addition, the spatial distribution of mold on the back of gypsum drywall (near the top edge, where the drywall contacted double top plates that were dry in service) was consistent with the occurrence during construction of rainwater penetration at the rim joist. As indicated in footnote 5, the spun-bonded polyolefin house wrap that covered first-story walls and the rim joist was initially reverse-lapped with the
