Historic Log Cabin Structural Condition Assessment and Rehabilitation – A Case Study

These inspections were completed by members of our project team and our cooperators and served as the basis for the development of technical inspection reports and our webinar series. This paper details the results of a comprehensive inspection and assessment of the Bearskin Lake Cabin owned by the U.S. Forest Service, Superior National Forest.

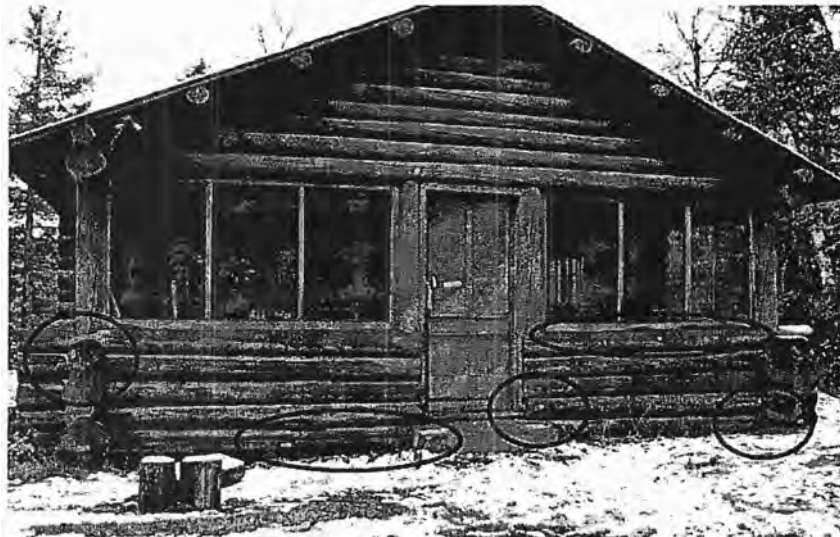
A visual inspection of the log cabin interior and exterior noted several locations of decay, insect infestation, water damage and bird damage. Figure 1 show the specific locations of the damage noted on the front of the building and figure 2 shows close-up areas of typical damage. The cabin is identified by noting the front had a porch entrance and the rear had a kitchen entrance. The cabin sides were noted as right and left as a person would enter the front porch. Visible decay was present on log ends and log comers around the cabin. It was often located on the lowest log, which was located within 6-10 inches of the ground. These logs receive backsplash from the ground and often had vegetation in near contact. A section was noted on the left side of the cabin where firewood had been stacked in direct contact, providing moisture and insect access points. Several sections of the lower sill logs contained significant insect damage from various types of beetles. There was also log decay noted along the screen windows on the front porch, where moisture entered the logs.

Figure 1 - Front left cabin with visual damage noted within circles or ovals.

- There was visible decay present on several of the lower log ends, log comers and sill logs. This decay should be addressed through accepted restoration techniques. This may include patching, wooden plugs, wood preservative, insecticides, and replacement of ends, half-logs or full logs.

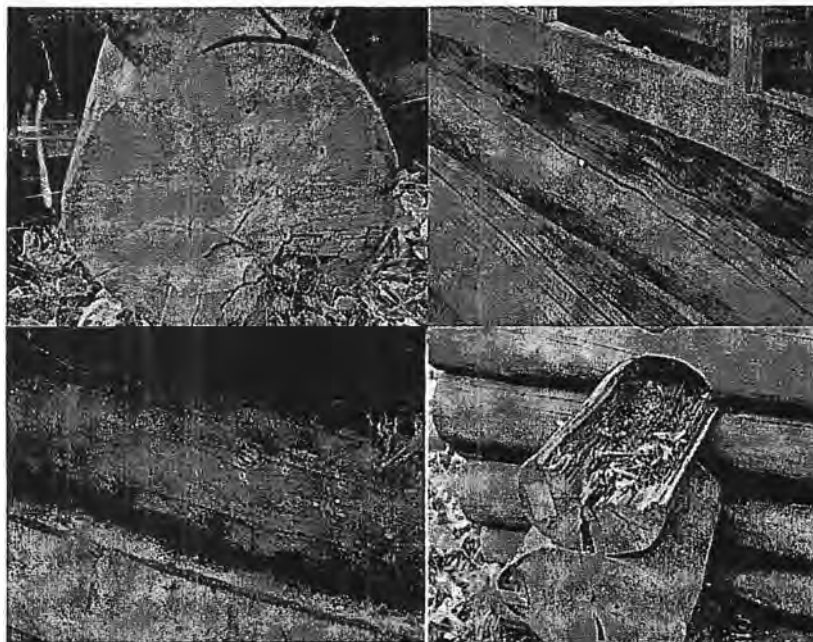
Figure 2 - Close-up of typical decay and insect damage noted during visual inspection

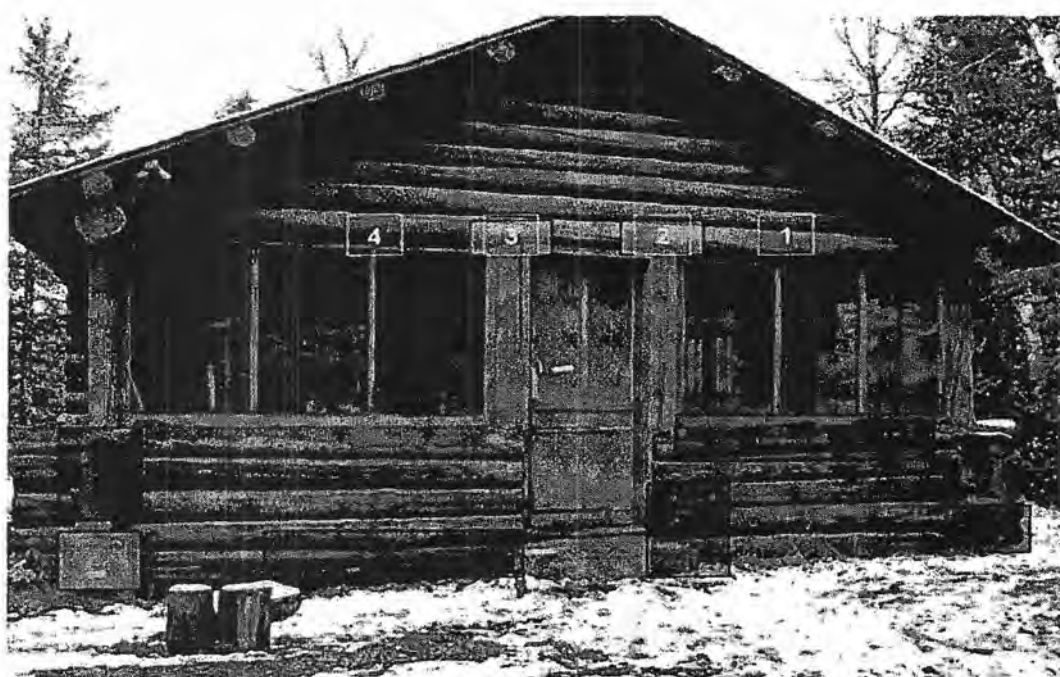
Decay was noted in several exposed log corners and ends where decay was not noted during visual inspection. The damaged logs were most often those closest to the ground. We identified hidden decay in several locations on the front of the building and on the rear of the building. The decay on the rear of the building was not visual. Two sensors are used in stress wave timing to determine the time it takes for a wave to travel through the logs. Transit times greater than 200 μ s/ft. are indicators of decay. Resistance drilling values ranging from 0-25% confirm varying levels of decay.

Figure 3 shows an overview of the cabin front. The sections of decayed logs identified using stress wave timings and resistance drilling techniques are shown in dark shading if they are categorized as substantial decay and light shading as moderate decay. The stress wave timing data for these sections was inadvertently destroyed, but the resistance drilling confirmed the damage in these locations. Figure 4 shows the resistance drilling data collected from locations 1, 2, 3, and 4 on the log above the porch door. This data shows that there is no internal decay at sections 1 or 4, but that there is a 3-inch diameter decay pocket located above each vertical log at locations 2 and 3. This was an approximately 10-inch diameter log.

Figure 3 - Bearskin cabin front showing decayed sections as identified through visual inspection, stress wave timing and resistance drilling. Dark shading reflects areas of severe decay and light shading areas of moderate decay.

- Decay that was not visible was identified through stress wave timing and resistance drilling. This includes logs on the cabin front below the porch screens and door, the cabin left and right sides and the rear of the cabin. The most significant problems were identified on the cabin rear, most likely caused by water from the kitchen sink, and close contact with the ground. This decay should be addressed through accepted log restoration techniques. This may include patching, wooden plugs, wood preservative, insecticides, and replacement of ends, half-logs or full logs.

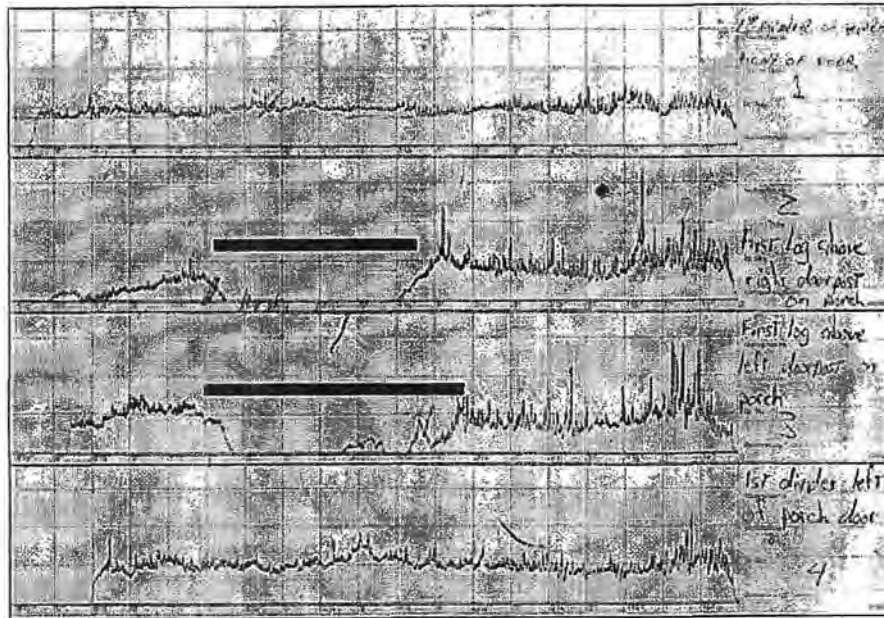
Figure 4 - Resistance microdrilling results from the log above the porch windows as identified by drilling locations 1, 2, 3, and 4 as seen in figure 3. The dark bar indicates decayed sections.

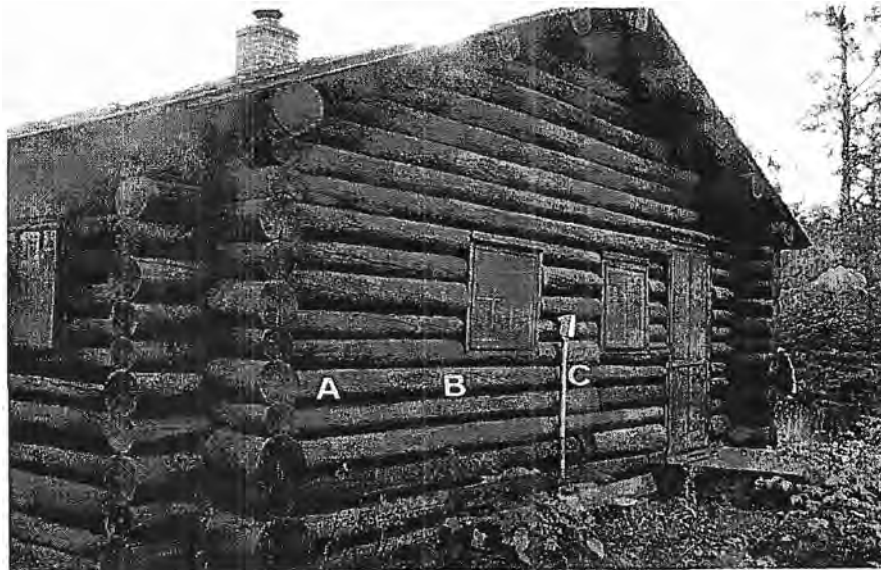
Figure 5 shows the rear side of the Bearskin guard cabin. There were no visual indications of decay present. The inspection using stress wave timing identified significant levels and areas of decay in the logs under the rear kitchen window. A sink exists in the kitchen and was the likely source of the water damage to the logs under the window. Figure 6 shows the stress wave timing data recorded for sections B and C. Stress wave transit times over 200 microseconds/ft. ($\mu\text{s}/\text{ft.}$) suggests intermediate decay and numbers over 400 $\mu\text{s}/\text{ft.}$ suggest significant decay.

Figure 5 - Rear side of Bearskin cabin showing decayed logs as shaded sections.

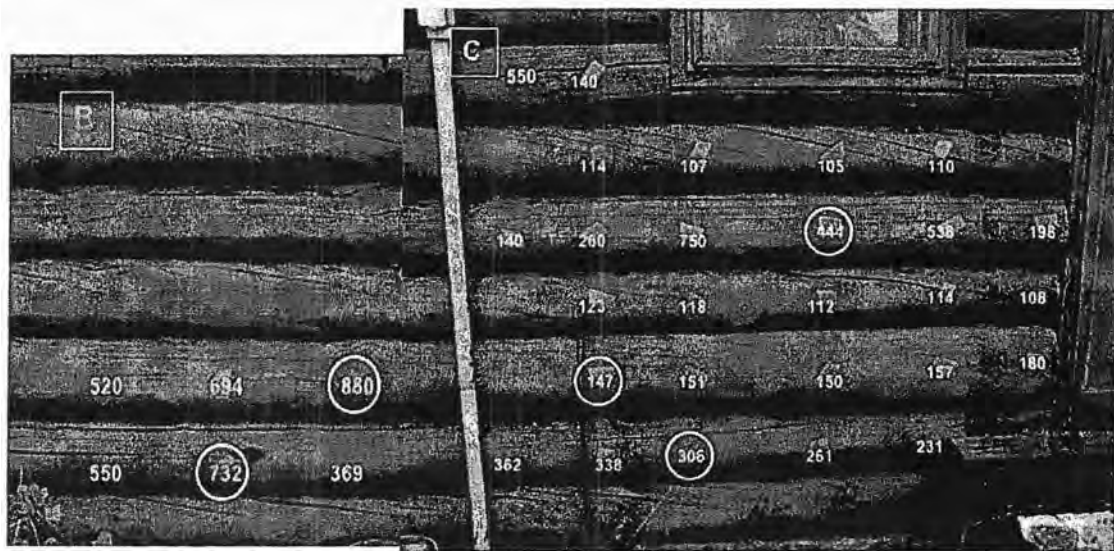
Figure 6 - Rear wall sections B and C show close-up data generated using stress wave timing. The data is shown as microseconds (μs) and the logs were approximately 8 inches diameter.

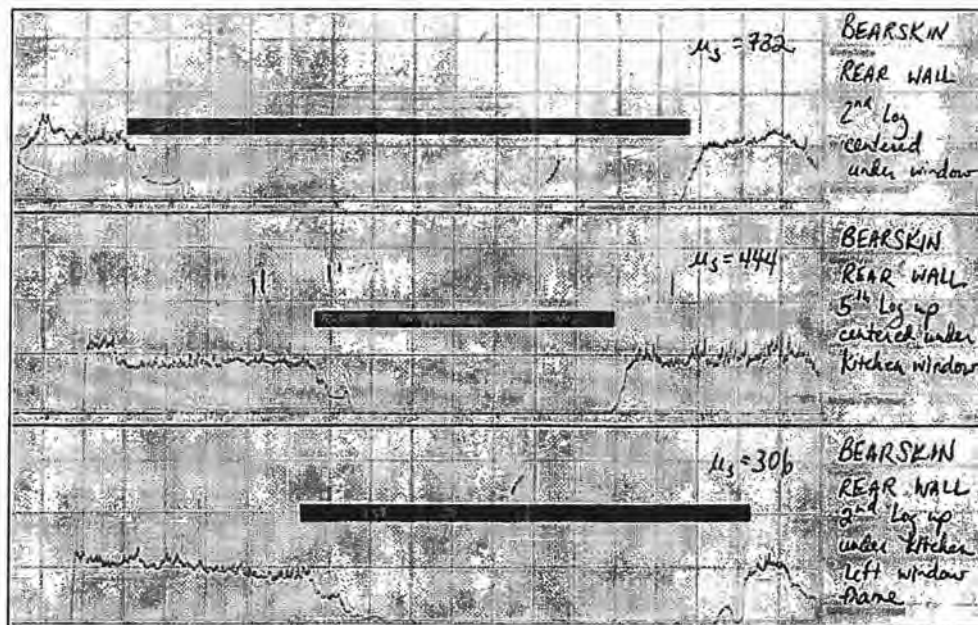
A resistance microdrill was used to confirm levels of decay as noted using stress wave timing techniques. Figure 7 shows resistance microdrilling data at various stress wave locations as noted.

Figure 7 - Resistance drilling data from various locations on rear cabin wall. The microseconds noted on the chart correspond to the drilling location as show on Figure 6.
