**Modern Instrumental Methods to Investigate the Mechanism of
Biological Decay in Wood Plastic Composites**

Grace Sun¹, Rebecca Ibach², Marek Gnatowski¹, Jessie Glaeser³, Mathew Leung¹, and John Haight³

Paper prepared for the 45th IRG Annual Meeting
St George, Utah, USA
11-15 May 2014

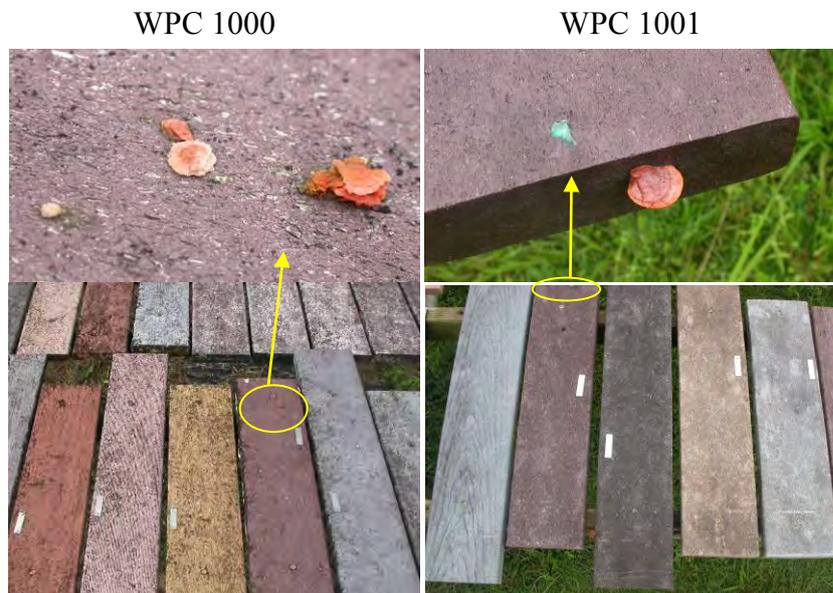
After 28 months of field exposure (in 2007), board 1000 and 1001 showed no obvious signs of fungal growth. Periodical field inspections showed fruiting bodies of decay fungi on WPC boards starting at 40 months of exposure at the sun location. Further inspection a year later showed fruiting bodies on boards exposed in both sun and shadow locations. Additional fruiting bodies were observed with increasing exposure time. Fig. 2 shows the 1000 and 1001 boards in 2009 (51 months of exposure) with visible fruiting bodies. This was the last inspection of the boards before their collection for evaluation in 2012. Some of the fruiting bodies visible on the surface of the boards after 8 years exposure (November 2012), photographed just before the detailed examinations described in this paper, are shown in Fig. 3 and 4.

Figure 2: WPC 1000 exposed in shadow location (Left) and 1001 in sun location (Right) in 2009. Areas of interest containing fungi fruiting bodies are marked.

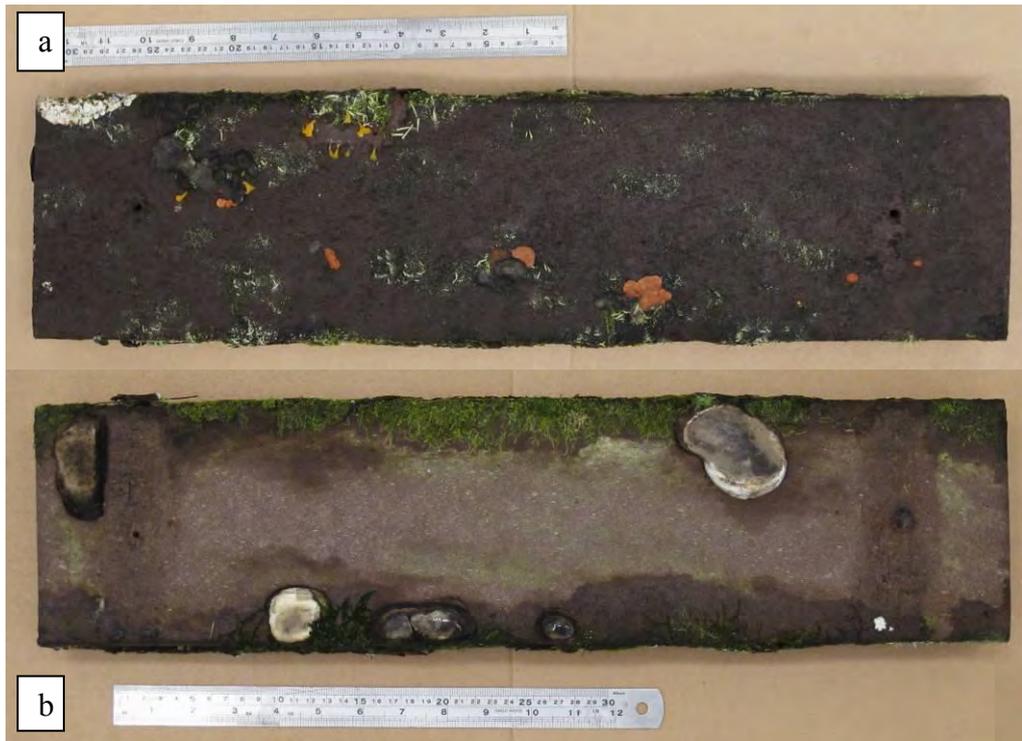
Fig. 3: WPC 1000 after 8 years of shadow exposure, showing (a) top side and (b) bottom side

At least six different species of wood-inhabiting fungi were fruiting on the boards. The bright yellow fruiting bodies, shown in Fig. 3a, are *Dacryopinax spathularia*, a jelly fungus that causes brown-rot. It is a common fungus in Hawaii (Hemmes and Desjardin, 2002) and is frequently associated with plywood, two-by-fours, lanai railings, or any other wood that is wet. The other fungi could not be definitively identified to species due to the lack of basidiospores in the dried specimens. The red fruiting bodies in Fig. 3a and 4a are tentatively identified as the polypore *Pycnoporus sanguineus*, a white rot fungus that is one of the most common shelf polypores in Hawaii (Hemmes and Desjardin, 2002), commonly found on stumps, fallen logs and branches.

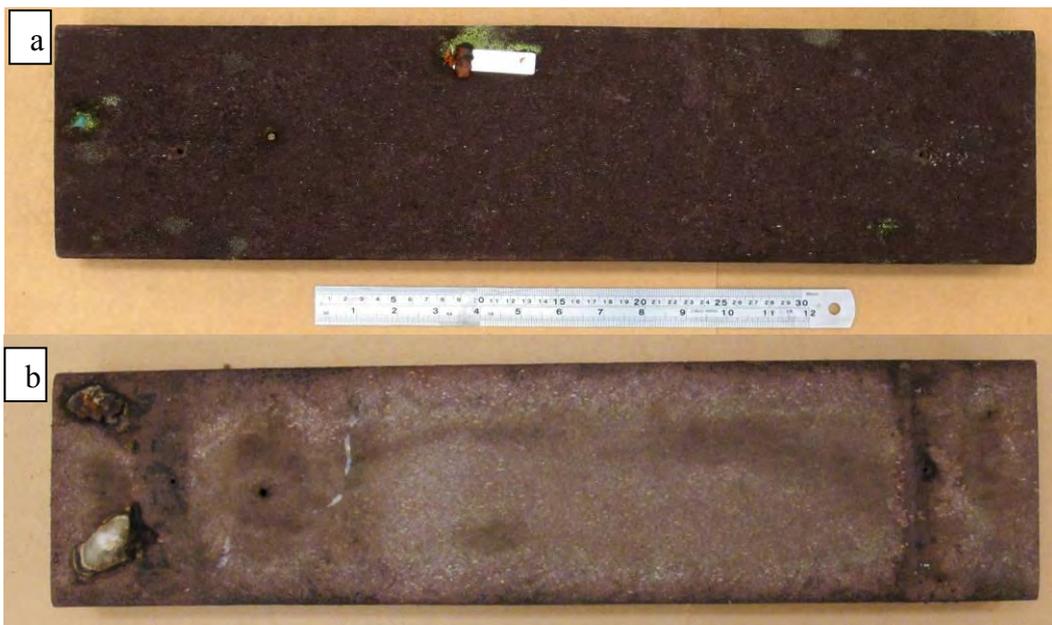
Fig. 4: WPC 1001 after 8 years of sun exposure, showing (a) top side and (b) bottom side

The green fruiting body shown in Fig. 4a is most likely a species of the genus *Chlorociboria*, a staining fungus that does not cause significant decay. Other fungi shown in Fig. 3b and 4b may include species within the white-rot genera *Phellinus* and possibly *Ganoderma*; identification to species was not possible due to the extensive degeneration of the old fruiting bodies. Several small, thin fruiting bodies were also observed; these were sterile and could not be identified to genus. The material supports a wide variety of wood-inhabiting fungi, many of which can cause decay.

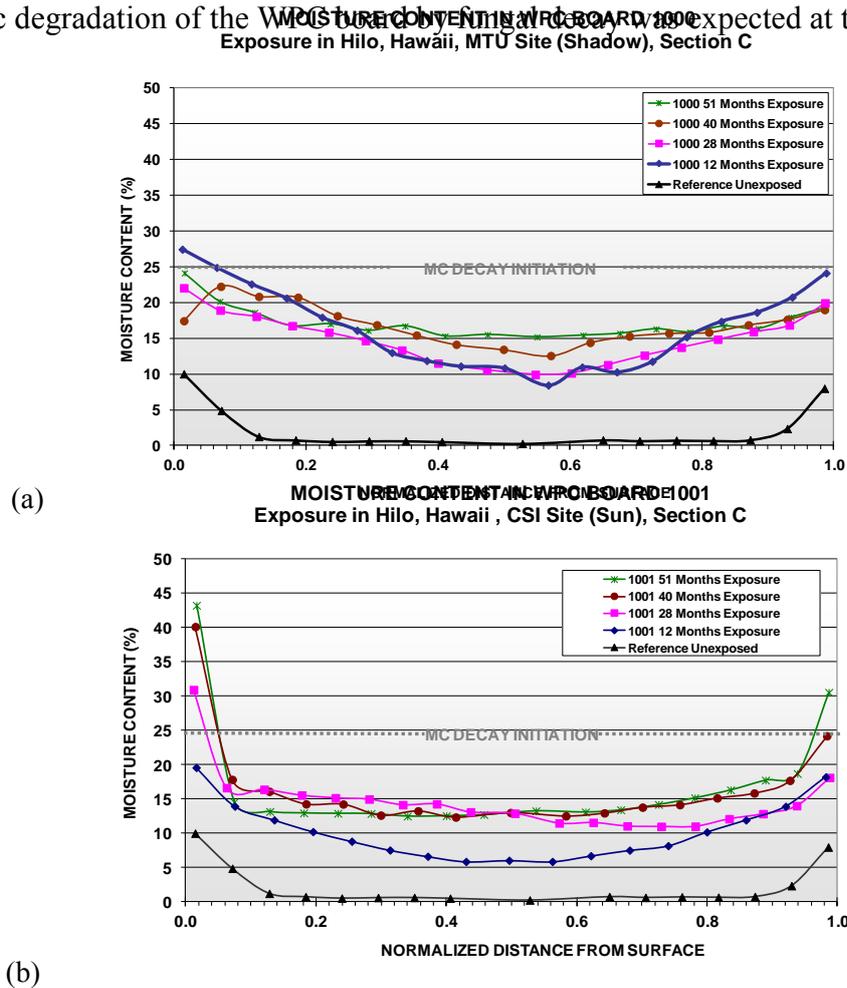
Moisture content and distribution during the first 51 months of exposure in both sun and shadow locations is shown in Fig. 5. The moisture content and distribution in the graphs indicated relatively moderate water absorption by the boards during this period of time. The MC in wood exceeded 25% only in narrow zones near the board surface in both sun and shadow locations. No catastrophic degradation of the WPC component was expected at this time.

Figure 5: Moisture content and distribution in the wood component of (a) WPC #1000 exposed in shadow and (b) WPC #1001 exposed in sun, over a 51 month period

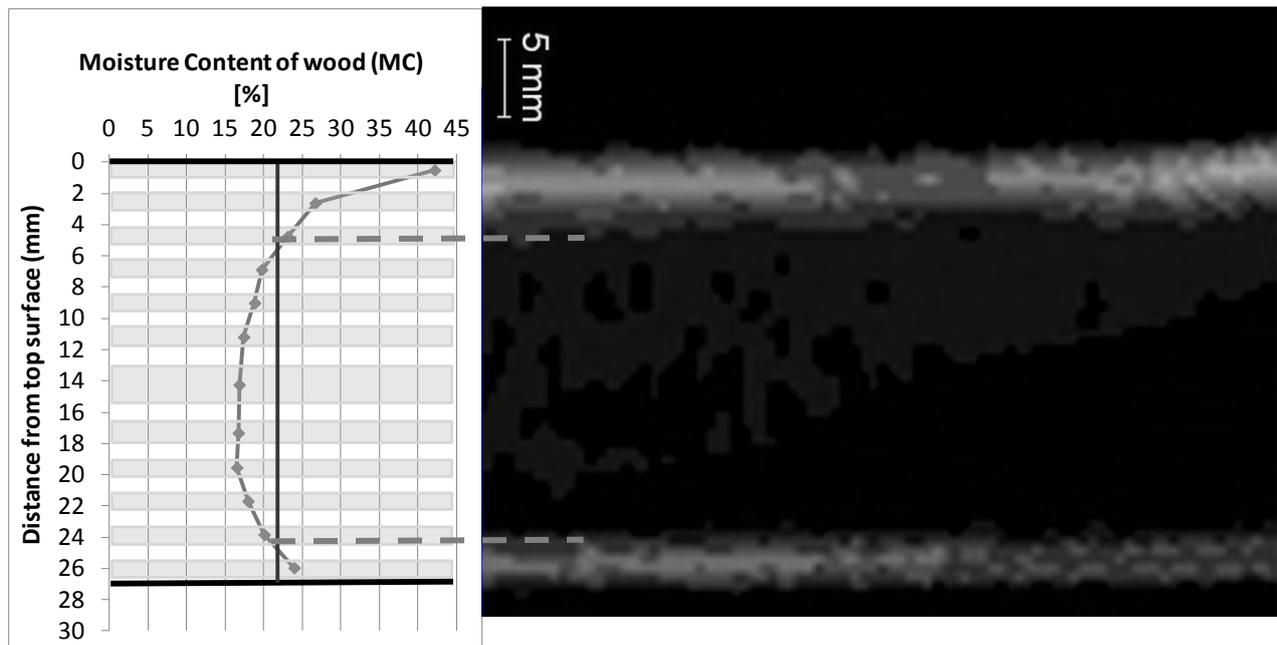
As shown in Fig. 6, the bright part of the image became gray and began to disappear, matching the black background around the point where the MC in wood reached 22 %. This indicated that the moisture saturation point was most likely reduced in the composite wood flour particles by about 5% as typical fibre saturation occurs for most solid wood species at MC of about 27 to 30%. In general, there is a good correlation between MR images and MC measured by destructive testing involving drying of the samples taken. This experiment confirmed the expectation that free water in WPC could be effectively detected by MRI at a concentration close to fibre saturation or above it using a clinical MRI unit in a non-destructive manner. The MR image shows the border outlining zones of free water presence, i.e. the corresponding potential region of decay activity, and it should be expected that the MC of individual wood particles in these areas may vary to some degree from the 22% detected.

Figure 6: MRI image obtained from plane 2 of experimental WPC #106 showing strong correlation to the moisture content distribution (from destructive testing) throughout the thickness of the imaged region

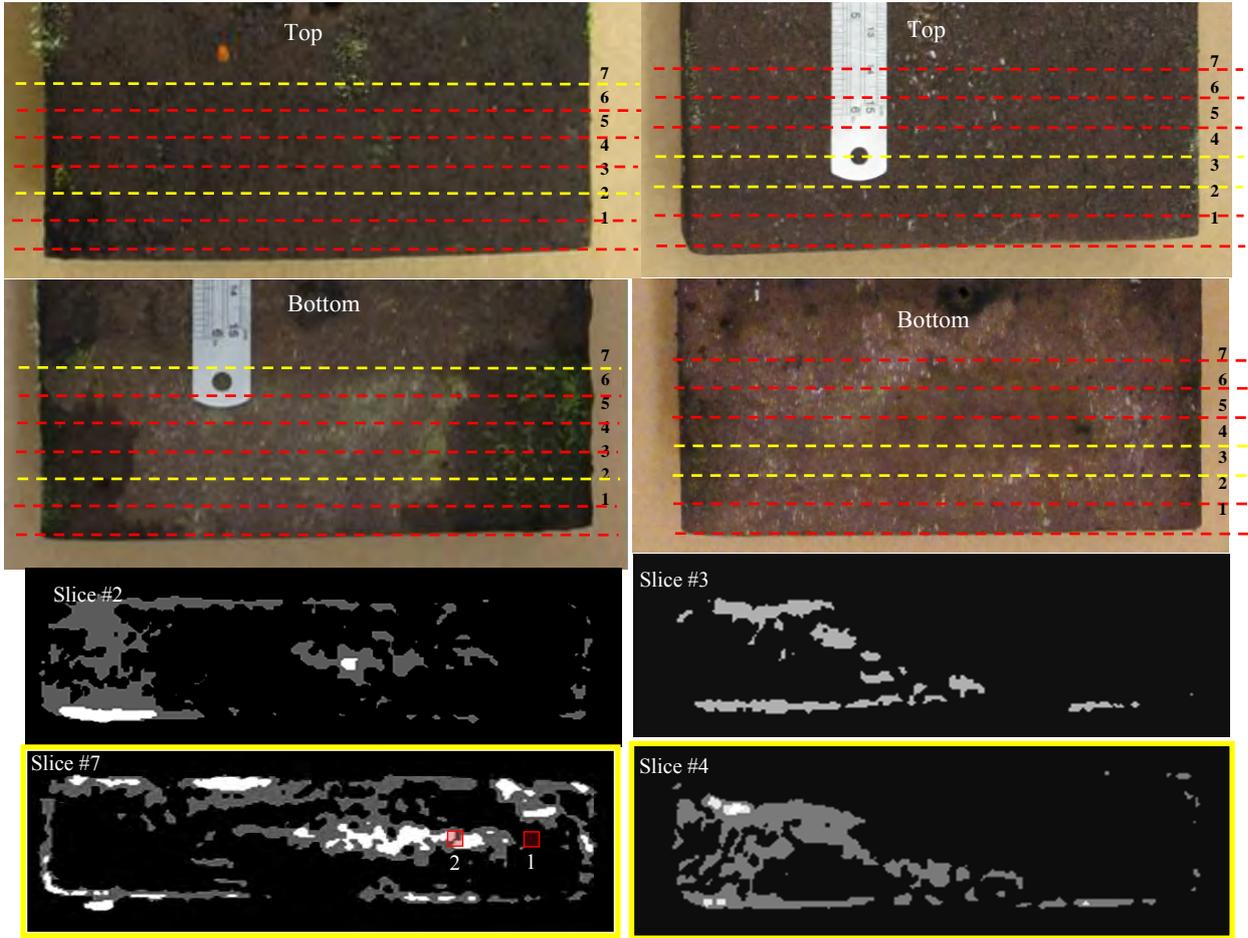
Non-destructive MR images of the boards showed significant bright areas (spots) visible in the cross-section pictures near the board surface as well as many locations inside the board. In earlier work (Gnatowski *et al* 2014), it was shown that the bright areas indicated the presence of free water in concentrations above the fiber saturation point in the wood flour particles. Selected images of both boards and the location from which they were obtained are shown in Fig. 7. The marked Areas 1 and 2 were later points of focus in the CT and SEM evaluations. The pattern and geometry of areas containing free water are difficult to fully explain at this point and may be attributed to non-uniform wood distribution in the plastic. There is also the strong possibility that the free water detected inside the board was a result of the ongoing decay process. During decay, cellulose of the wood is transformed into CO₂ and H₂O following the reaction (Muller *et al* 2001):

The presence of free water does indicate good conditions for decay fungal growth in these areas. Water generation during the decay process may propagate decay in the WPC due to the entrapment of moisture inside the composite material and its limited water transfer and drying properties. The commercial boards (1000 and 1001) were cut along the MRI slice lines

Figure 7: WPC 1000 (left) and 1001(right) imaged by MRI after 8 year of exterior exposure. MRI images of selected cross sections, marked with yellow lines, are presented. Boxed areas 1 and 2 on Slice #7 from WPC 1000 indicate the locations used for subsequent CT and SEM evaluation.

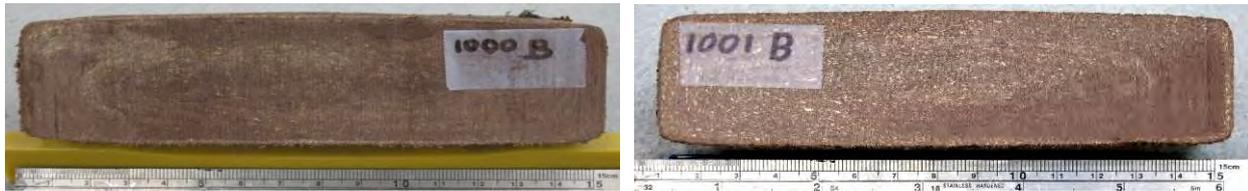
mentioned above and photographs of the cross-sections are shown in Fig. 8. Wood particles are still well-visible in the cross-sections despite the extensive decay which was later confirmed by SEM and described in Section 3.4.

Figure 8: Cross-sections of WPC 1000 corresponding to MRI image slice #4 in Fig. 7 (left) and WPC 1001 corresponding to MRI image slice #7 in Fig. 7 (right)

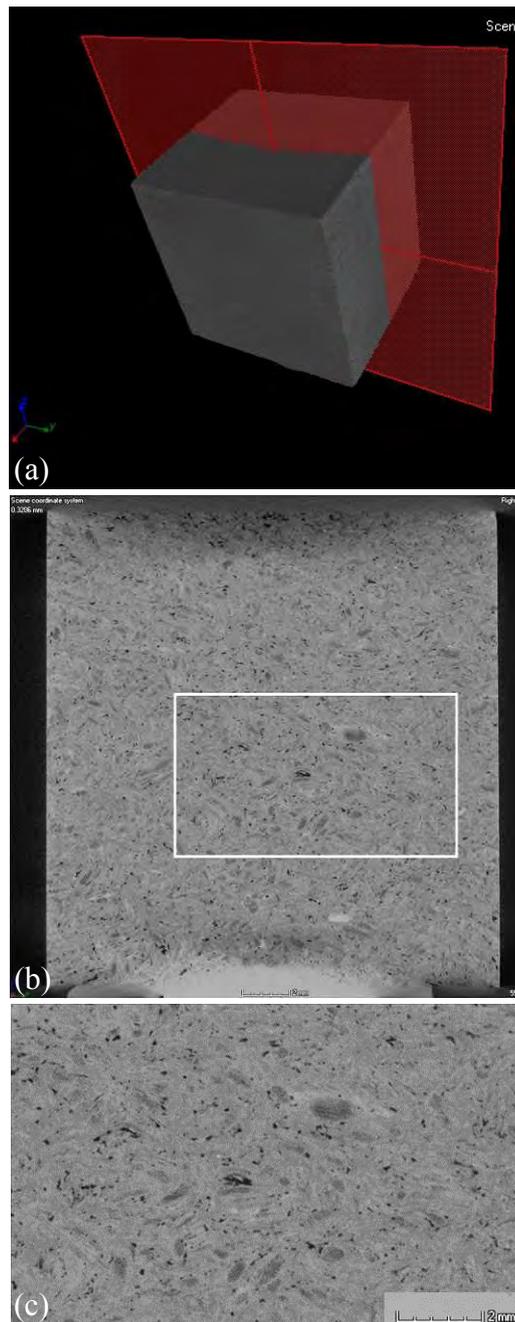
Figure 9: CT images taken in the extrusion direction at the center of the reconstructed volume of experimental reference control sample 8R2 with (a) plane indicator showing where the image was obtained (b) overview image and (c) higher magnification view of voids and wood particles present

Fig. 9c shows that even in the reference material (8R2), there are a number of voids present, as indicated by the darkest areas (of lowest density) on the image. Some individual wood particles can be observed interspersed throughout the polymer matrix; many of these particles appear to be darker grey in colour as compared to the bulk of the material, potentially due to voids that are not filled with resin. Fig. 10c and 11c show the microstructure of samples 8G2 and 8F2 which have both undergone 5 day water immersion at 70°C. It can be seen that microcrack development, in the form of dark outlines, appears to be associated with the pattern of the die used. Sample 8F2 (Fig 11c), which was exposed to fungal decay, shows particularly severe crack development. The structure of the composite, associated with the typical density pattern in relation to the extrusion die used, is well visible on the images.

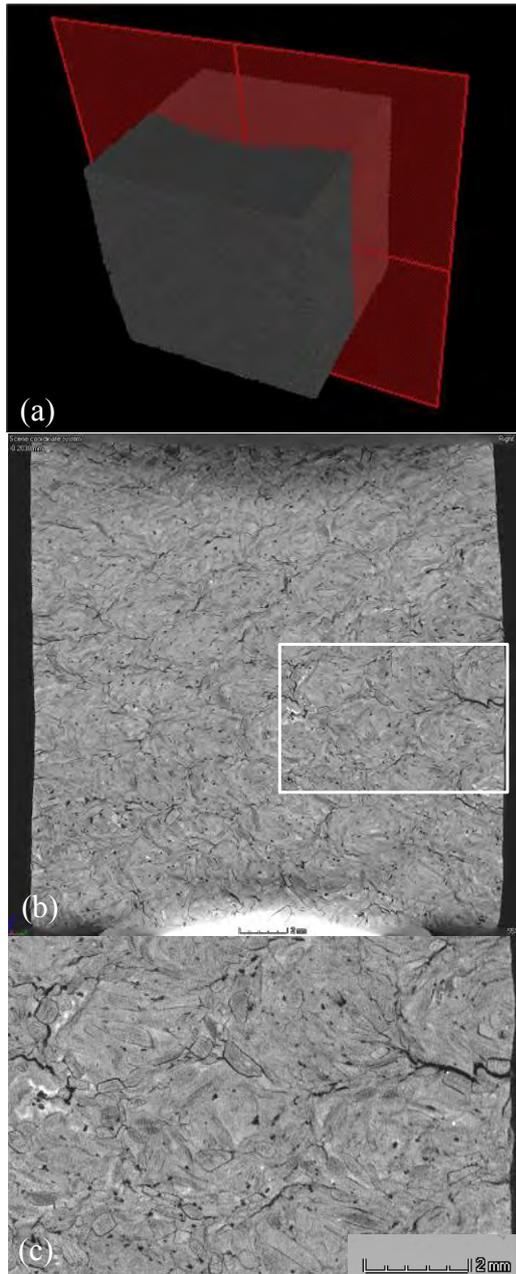
Figure 10: CT images taken in the extrusion direction at the center of the reconstructed volume of experimental conditioned and soil block tested with no fungi sample 8G2 with (a) plane indicator showing where the image was obtained (b) overview image and (c) higher magnification view of microcrack development

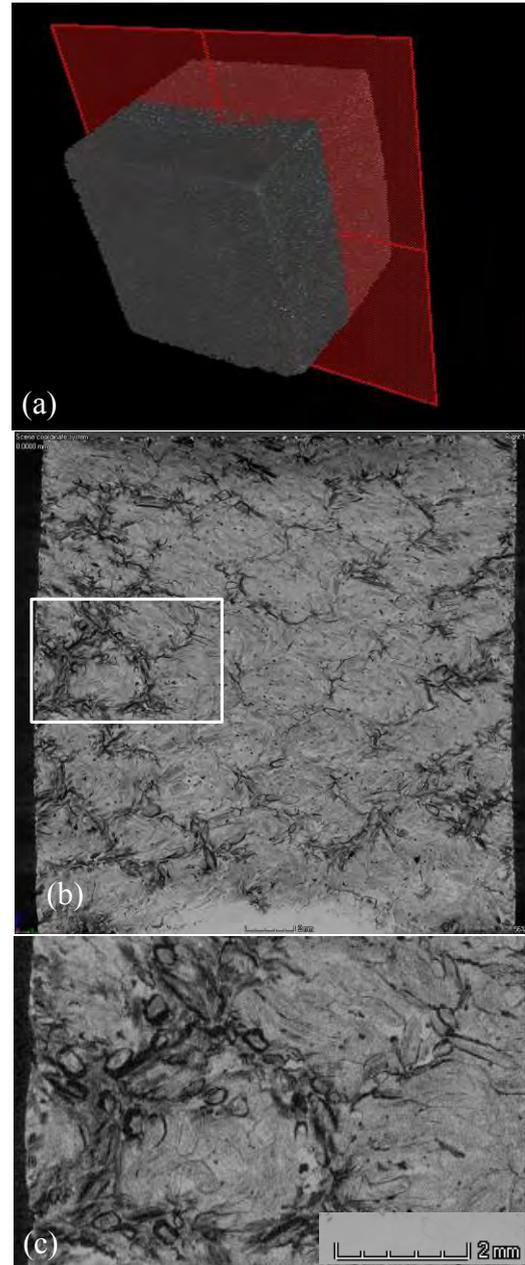
Figure 11: CT images taken in the extrusion direction at the center of the reconstructed volume of experimental conditioned and decayed sample 8F2 with (a) plane indicator showing where the image was obtained (b) overview image and (c) higher magnification view of severe microcrack propagation

As mentioned, voids are present in each of the samples, with the greatest average volume percentage of voids in 8F2 ($V_{8F2} = 12.5\%$), followed by 8G2 ($V_{8G2} = 3.8\%$), and finally 8R2 ($V_{8R2} = 1.7\%$) (Table 1). This trend corresponds well to the weight loss in wood previously found experimentally for the samples, where 28.9% loss had been observed in 8F2 and 4.4% loss was observed for 8G2.

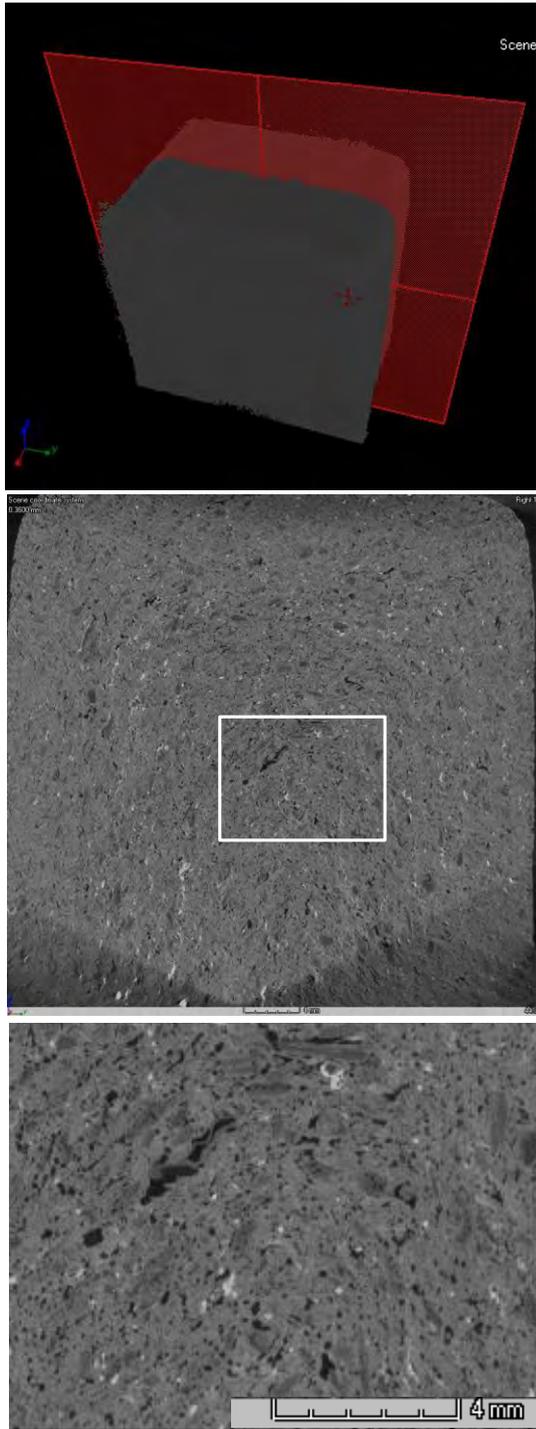
In the reference sample, good distinction of wood particles and voids was achieved. Relatively coarser wood particles and voids were observed (Fig. 12c). The exposed 1000B sample showed a significant number of relatively large dark grey or black areas, most likely voids present in the residual space of decayed wood particles (Fig. 13c). From the greyscale density on the images, it is very difficult to establish an exact decrease in wood density of individual areas of interest, but it could be concluded that the decrease between the reference and exposed commercial samples is significant. The voids seemed to be distributed relatively uniformly across the whole evaluated volume of the exposed 1000B sample, indicating severe and almost complete decay of wood particles.

Figure 12: CT images taken in the extrusion direction at the center of the reconstructed volume of commercial reference sample 1000-1001 with (a) plane indicator showing where the image was obtained (b) overview image and (c) higher magnification view of voids and wood particles present

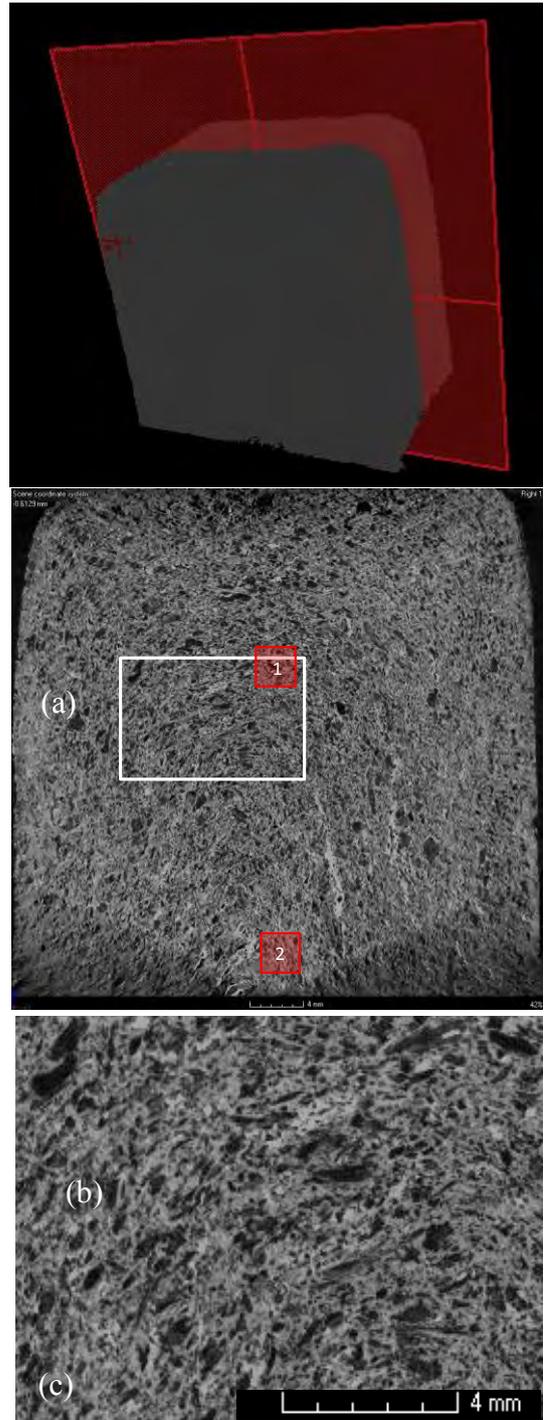
Void analysis conducted on these samples indicated a great number of voids present in the exposed 1000B cross-section compared to its reference counterpart (Table 1). The average volume percentages of voids for the exposed 1000B sample and the reference 1000-1001 sample were 31.3% and 5.4%, respectively. This indicated that about 25.9% of the voids may have been created by decay process. Based on the initial density of the sample (0.94 g/cm³) and its known wood content (53%), this would reflect 72.8% wood decay. Density measurements performed on segments of 1000B sample in the area included in the CT scan showed a significant decrease in comparison to the reference material. The exposed 1000B sample and the reference unexposed sample had densities of 0.60 g/cm³ and 0.94 g/cm³, respectively, which can be calculated an approximate 68% density loss in wood. This is in relatively good correlation to the wood decay determined by CT void analysis (72.8%). The average 5.4% voids found in the unexposed reference board also explains the relatively low initial density (0.94 g/cm³) of this board.

Figure 13: CT images taken in the extrusion direction at the center of the reconstructed volume of commercial exposed sample 1000B with (a) plane indicator showing where the image was obtained (b) overview image and (c) higher magnification view of an abundance of large voids. Boxed Areas 1 and 2 indicate the approximate sub-volume locations for void analysis and correspond to the MR image areas in Fig. 7.

There was no obvious relationship between the free water distribution in the 1000B board as detected by MRI and the average void volume percentage calculated from the CT scan. The calculated void volume content was very similar in two sub-volumes obtained near Areas 1 (28.2%) and 2 (28.7%) indicated in a 2D image of the CT reconstructed volume (Fig. 13b), regardless of the free water absence in Area 1 and its presence in Area 2 shown in the corresponding MR image taken in a similar area (Fig. 7). As mentioned earlier, the presence of free water inside the WPC board may be associated with the decay process still active on the residual wood.

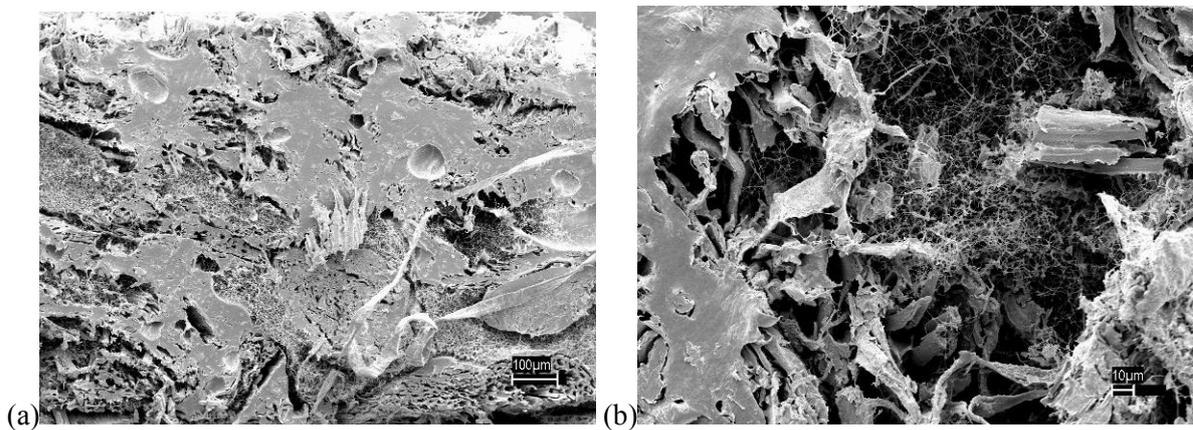
Fungi were present on wood pieces in all areas examined throughout the wafer cut from sample 1000B. Many wood pieces were heavily colonized (Fig. 14 and 15). The wood was degraded, with the destruction of the wood symptomatic of a white rot type of decay. Cell walls were thin, and loss of cell wall components caused the S2 layer to pull away from the middle lamella in some cells (Fig. 16). Cell walls were severely degraded in some areas leading to separation of individual wood fibers, loss of cell wall integrity and collapse of wood structure, creating voids occupied by masses of fungal mycelia (Fig. 15). Area 1 and Area 2, as indicated in previous MR (Fig. 7) and CT (Fig. 13) images had similar types and amounts of decay (Fig. 14 and 15), which was confirmed visually in all replicate samples.

Fig 14: (a) Low and (b) high magnification SEM images of 1000 B, Area 1 with heavy fungal colonization and decay of wood fibers. Area 1 corresponds to the location shown in the MR image in Fig. 7 and the CT image in Fig. 13.

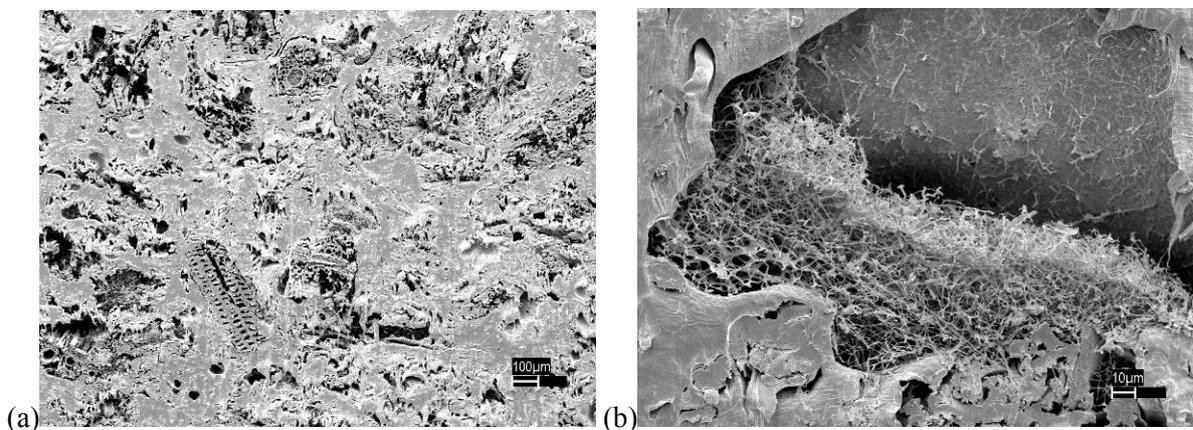
Fig 15: (a) Low and (b) high magnification SEM images of 1000 B, Area 2 showing collapsed wood cells, which left a void occupied by a mycelial mass of wood decay fungi. Area 2 corresponds to the location shown in the MR image in Fig. 7 and the CT image in Fig. 13.

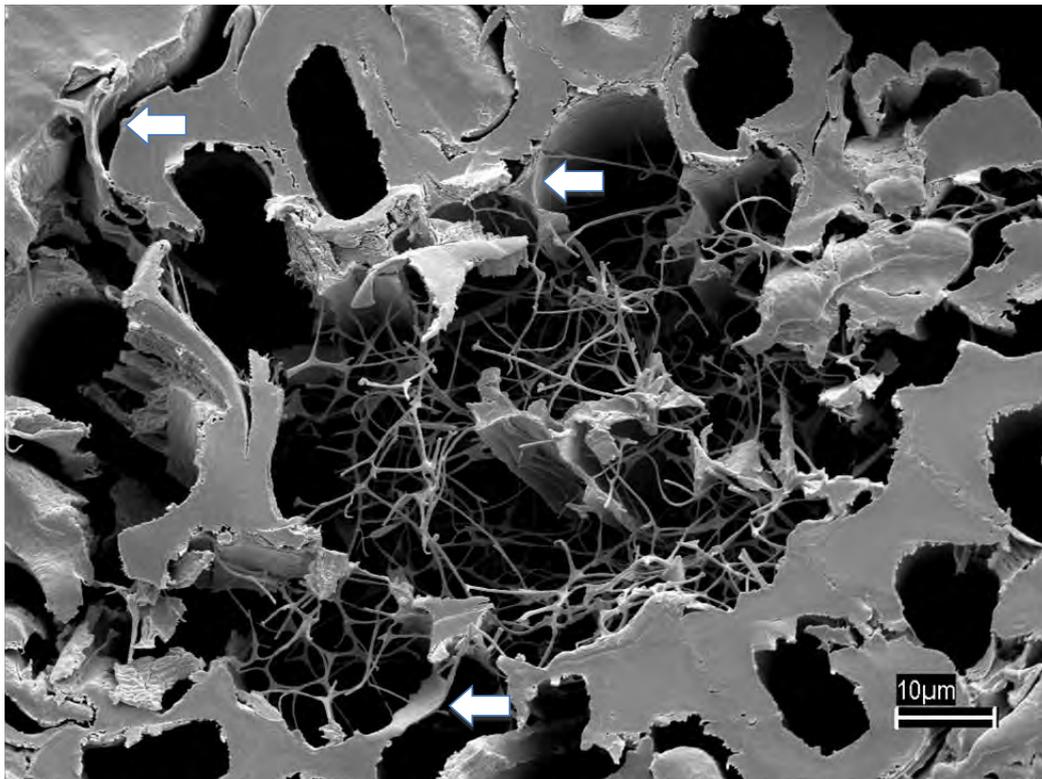
Fig 16: SEM image of 1000 B, Area 2 with symptoms of white rot decay including cell wall thinning, separation of cell wall layers from middle lamella and loss of structural integrity, as indicated by white arrows. Area 2 corresponds to the location shown in the MR image in Fig. 7 and the CT image in Fig. 13.
