Forest Service
U.S. DEPARTMENT OF AGRICULTURE

Forest Products Laboratory | General Technical Report FPL–GTR–300 | May 2024

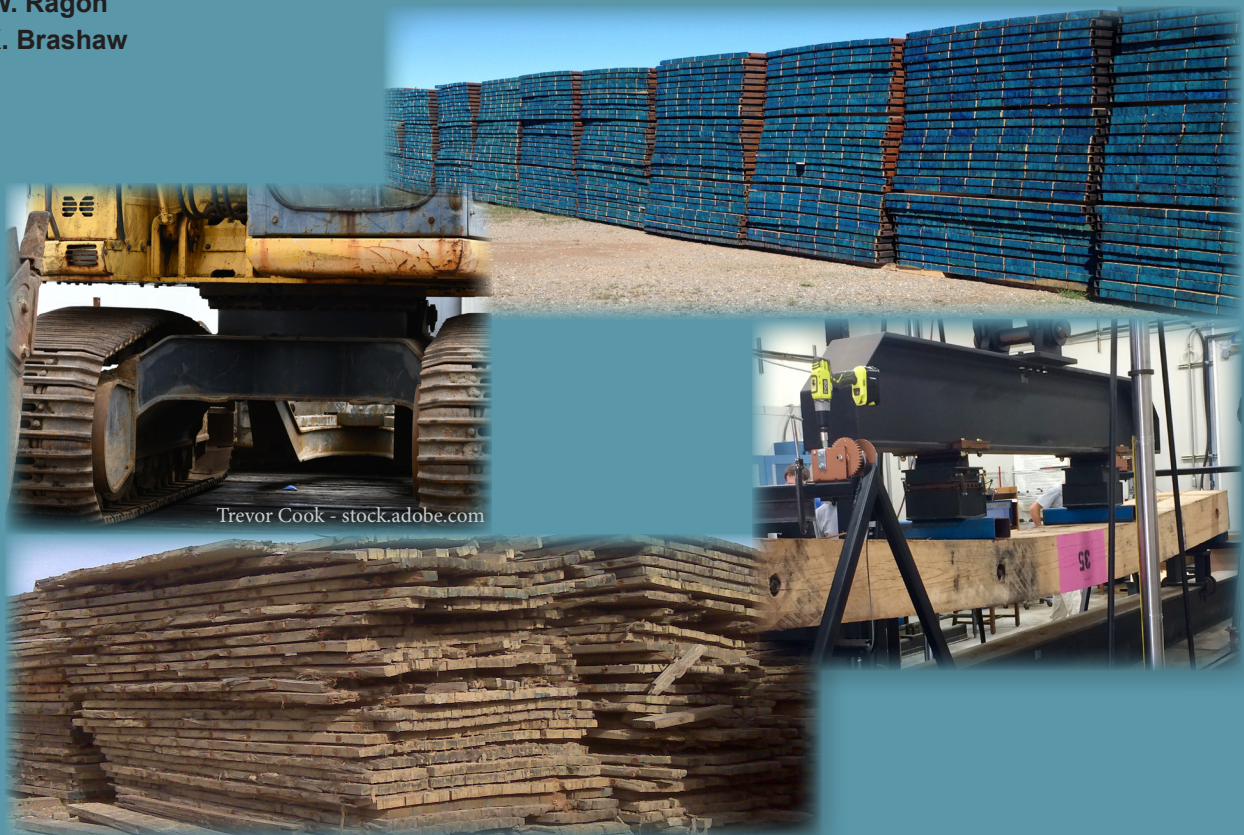
Other three cover photos used with permission from Rubin Shmulsky and Mississippi State University

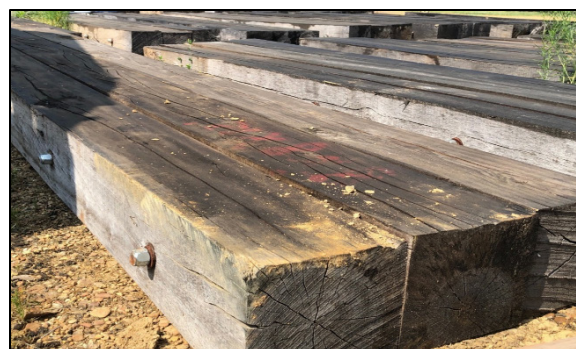
Figure 1—Timber mats that have been broken in flexural testing (8 in. (0.2 m) thick by 24 in. (0.6 m) wide by 14 ft (7.3 m) long). Used with permission from Mississippi State University.

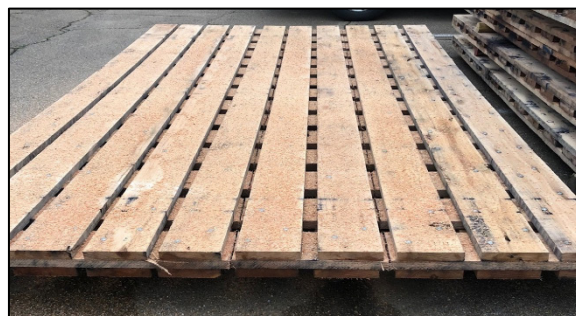
Figure 2—Three-ply oak mat (made from nominal 2- by 8-in. (standard 38- by 184-mm) planks) that has been cut into 2-ft-wide specimens prior to flexural testing. Used with permission from Mississippi State University.

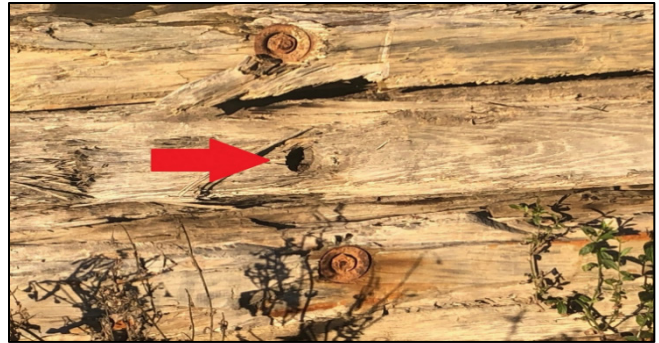
Figure 3—Stack of used mats. The mat in the middle exhibits a missing steel rod that would otherwise be holding the constituent timbers together and promoting load sharing. Photo is property of Mississippi State University.

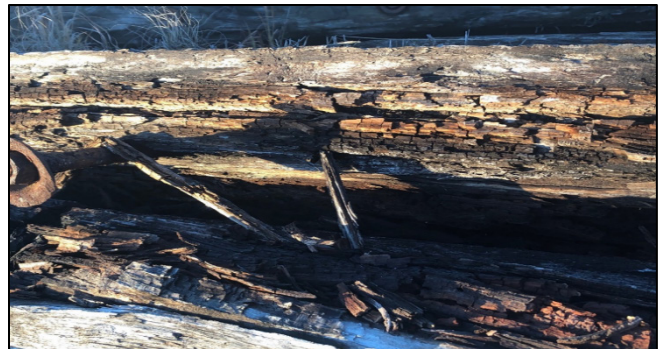
Figure 4—Advanced decay in a mat timber. This level of decay negates the mat's strength entirely. It is ready to be retired, stripped, and recycled. Photo is property of Mississippi State University.

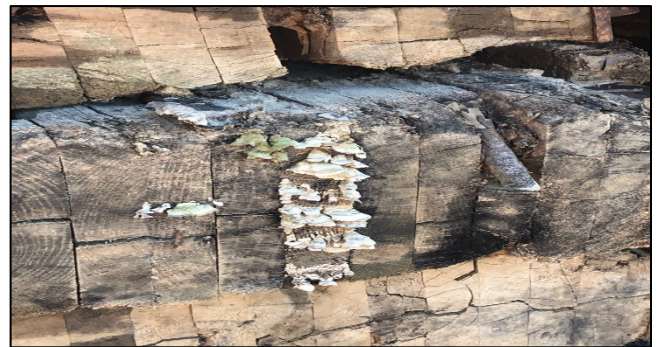
Figure 5—Fungal fruiting bodies on the end-grain of a glue-laminated mat timber. These fruiting bodies indicate advanced decay. The strength of this timber is thus significantly reduced and warrants further inspection and evaluation. Photo is property of Mississippi State University.

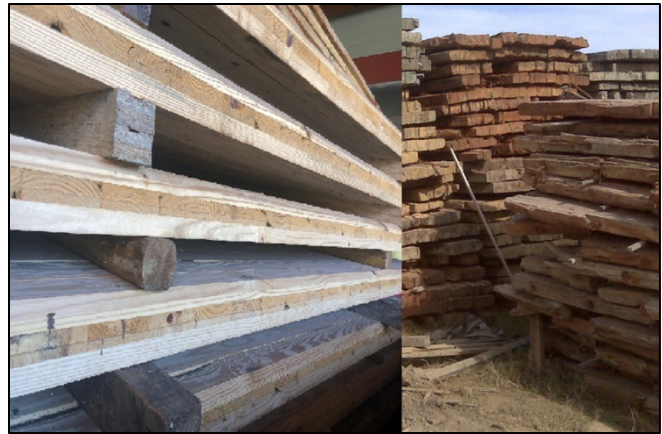
Figure 6—New 3-ply CLT mats (left) and used bolted mats (right). The used mats are staged for deconstruction and reconditioning in which the good timbers will be reassembled and again used as mats and the broken timbers will be chipped for fuel. In each photo, the individual mats are separated by cross outs (sticks or other dunnage) to facilitate both handling and airflow. Both photos are property of Mississippi State University.

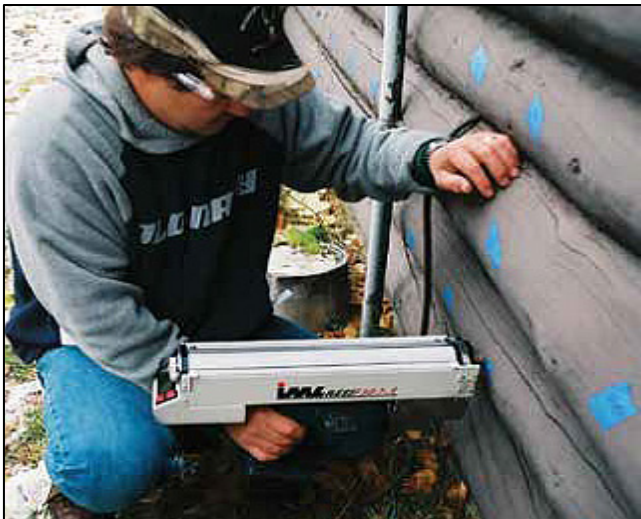
Figure 10—A resistance microdrill being used for inspection of a historic Civilian Conservation Corps log cabin.

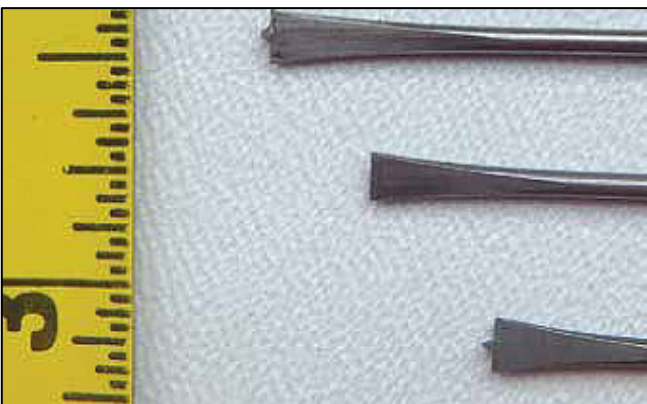
Figure 11—Flat-tipped resistance drill bits used to inspect timber materials.

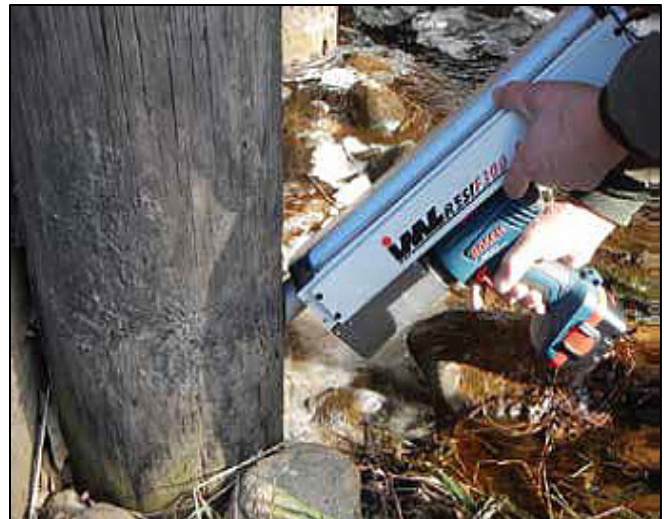
Figure 12—Drilling can be done at an angle to assess the area below the ground line.

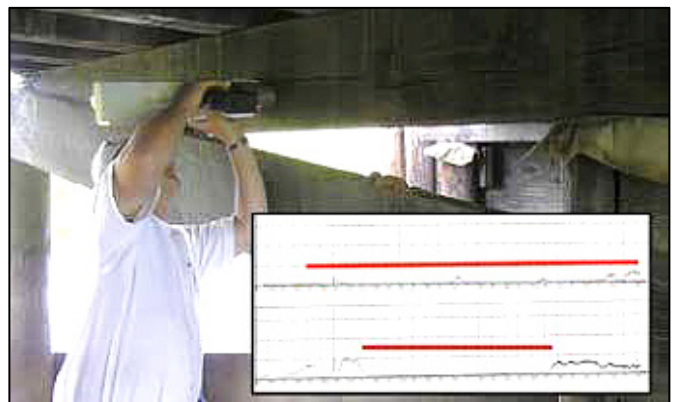
Figure 13—Resistance microdrilling showing significant decay in the bridge pile cap. The inlay shows the paper chart readout from a commercial drilling unit. This technique can be readily applied to mats and timber bridge structures.

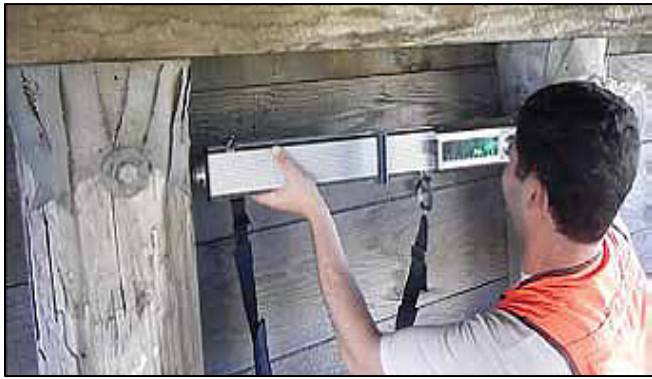
Figure 14—Electronic display on a resistance drill in use.

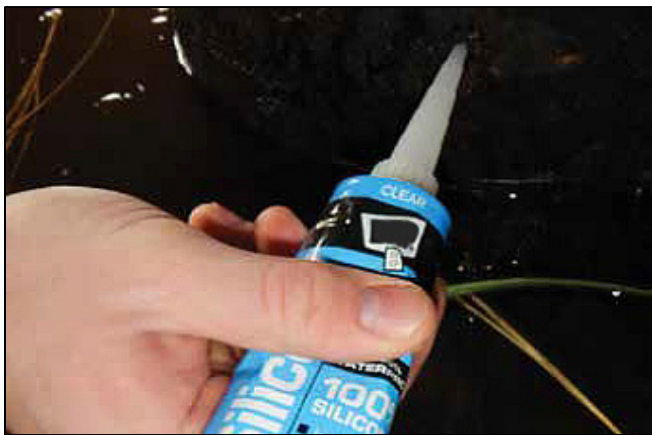
Figure 15—Silicone is used to fill the small drilling hole.

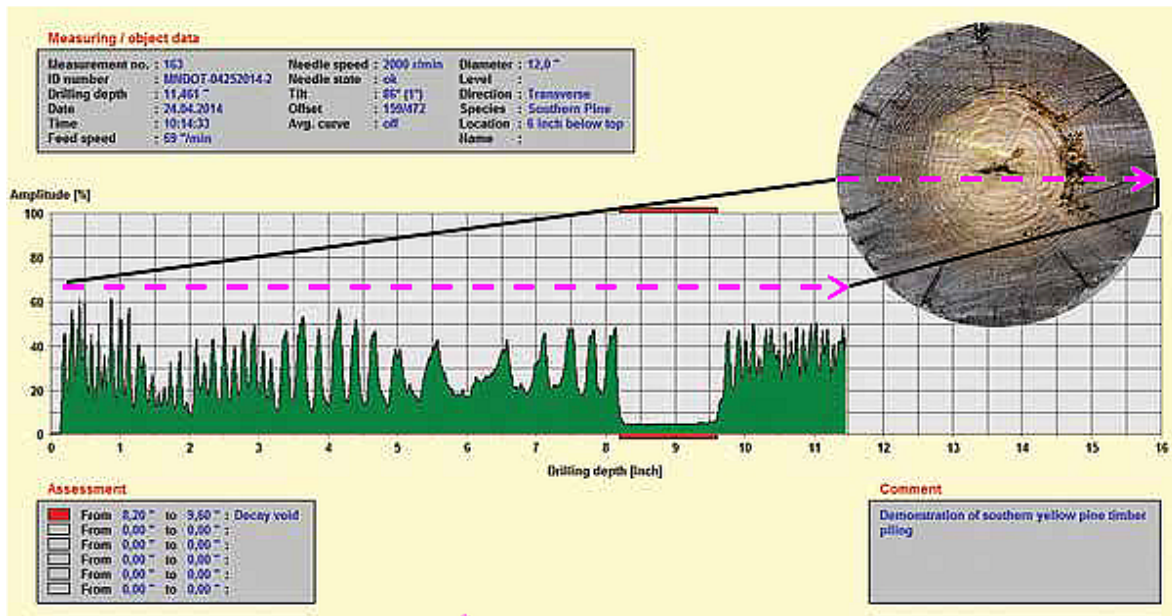
Figure 16—Electronic view of a southern yellow pine timber piling showing a decay pocket between 8 and 10 in. (0.2 and 0.25 m) of the drilling profile.

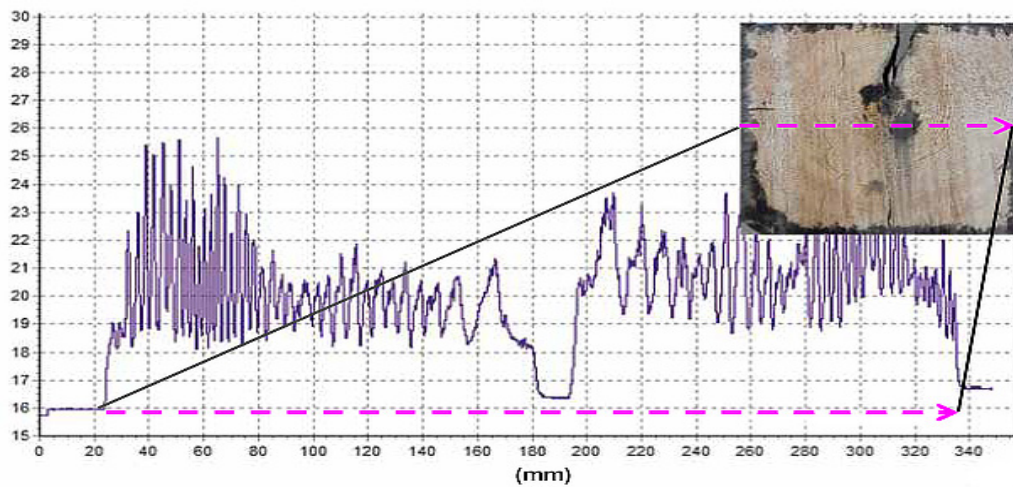
Figure 17—Electronic resistance chart of a Douglas-fir pile cap showing a large crack between 7.09 and 7.87 in. (180 and 200 mm) along the drilling path.
