**Post-layup protection of mass timber elements in above ground
protected exposures: 2-year results.**

Paper prepared for the IRG53 Scientific Conference on Wood Protection
Bled, Slovenia
29 May - 2 June, 2022

Post-layup protection of mass timber elements in above ground protected exposures: 2-year results

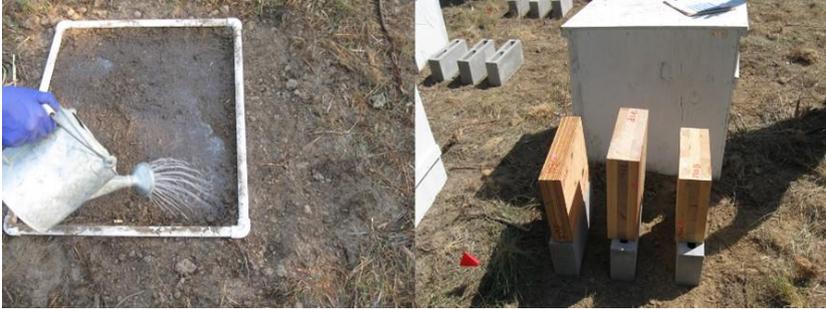
Figure 2: Drench treatment with fipronil soil termiticide and arrangement of ground bricks and CLT in soil termiticide subplots before covering. Note the hand tilled soil. PVC frame used as guide for insecticide application.

1. Soil termiticide only: A 0.61m x 0.61m area of the 0.76m x 0.76m subplot was drenched with a 0.125% fipronil [5-amino-3-cyano-1-(2, 6-dichloro-4-trifluoromethylphenyl)-4-fluoromethylsulfinyl pyrazole] solution (per gallon of water). Bricks and mass timber samples were placed on the treated area with as little soil disturbance as possible (Figure 2).

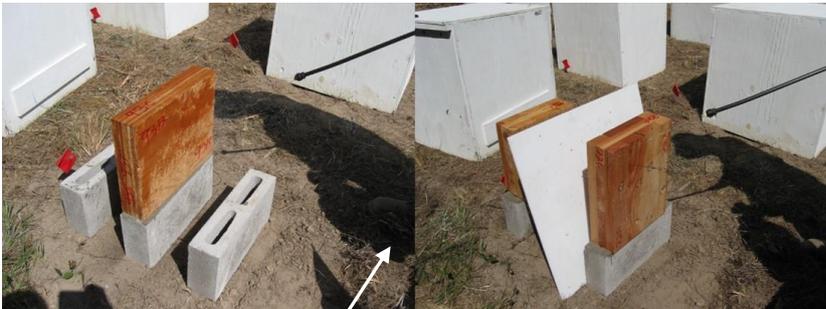
Figure 3: Arrangement of blocks and samples in subplots for preventive and remedial treatments sprayed with borate solution (23% DOT) before cover was placed over samples (note plastic barrier to minimize drift on adjacent samples).

2. Preventative borate spray: (Nisus, Knoxville, TN USA); 23% disodium octaborate tetrahydrate (DOT)) was applied to each mass timber sample of the six subplots. A plastic shield was placed over the adjacent sample on the cinder block before spraying to minimize excessive borate application to already sprayed samples (Figure 3).

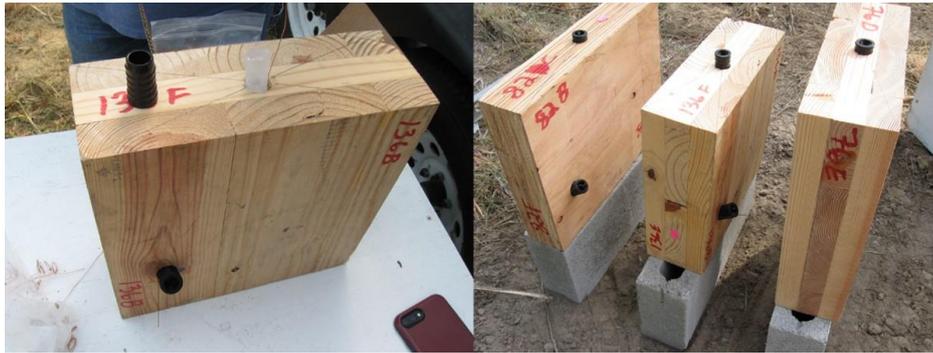
Figure 4: Arrangement of blocks and samples for boron rod treatment. Two rods placed in each sample at top and one face (left). Samples with rods capped, placed on blocks and covered (right).

3. Boron rods: Rods (WoodCare Systems, Kirkland, WA USA) were placed in bore holes at the top and on one face of each of the three mass plywood samples in each sub-plot. Top bore holes (19 mm in diameter by 114 mm deep) were drilled in the top center ply of each sample. Side bore holes were drilled at a 40° angle in the lower face of one side of the sample 105 mm from the bottom edge. Side face rod holes were drilled 60 mm deep. A 50 mm long solid boron rod was placed into each top bore hole along with a copper wire to help extract the rod for later weighing. The lower face bore holes received a 25 mm long rod along with wire for later extraction. All rod holes were plugged with plastic plugs (Figure 4).

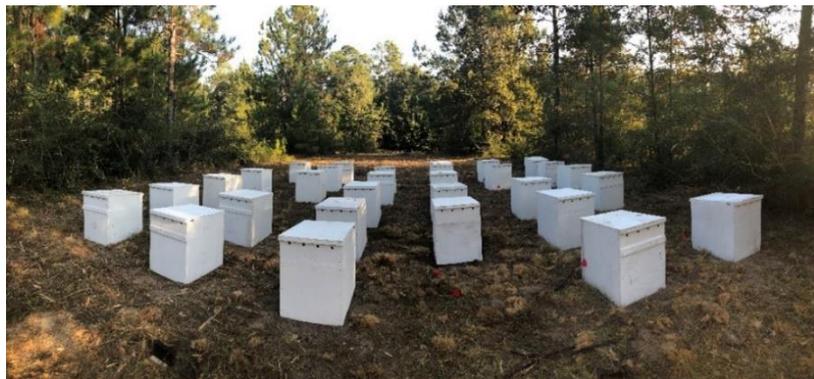
Figure 5: Photograph of all test assemblies at the experimental plot after covers were applied.

After placement and treatment, the samples were covered with pre-constructed ventilated plywood cover boxes with sloping roofs to help shed rain runoff (Figure 5). The covers were painted white to minimize heating. The front and back of each cover had four 25mm diameter mesh-covered ventilation holes. Samples remained undisturbed for two years except to check moisture in samples after 1.5 years. After 1.5 and 2 years, two moisture readings were taken on the top and bottom of the two broad faces of each sample using the Wagner meter, then the four moisture readings per sample were averaged and compared to pre-test initial (dry) moisture readings.

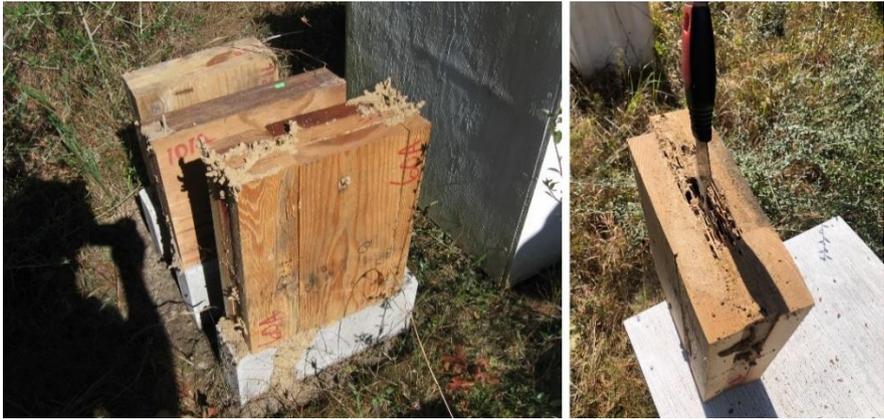
Figure 7: Examples of termite attack showing extensive mud tubes on a Douglas-fir CLT sample (left) and termite tunnelling and excavation underneath the sample at the two-year rating (right).
